ENGINEERING ASSESSMENT for SILVER CREEK DETENTION BASIN DAM

CITY OF ONEONTA

Document Date: February 18, 2014

Assessment Performed by: Richard C. Wakeman, P.E.

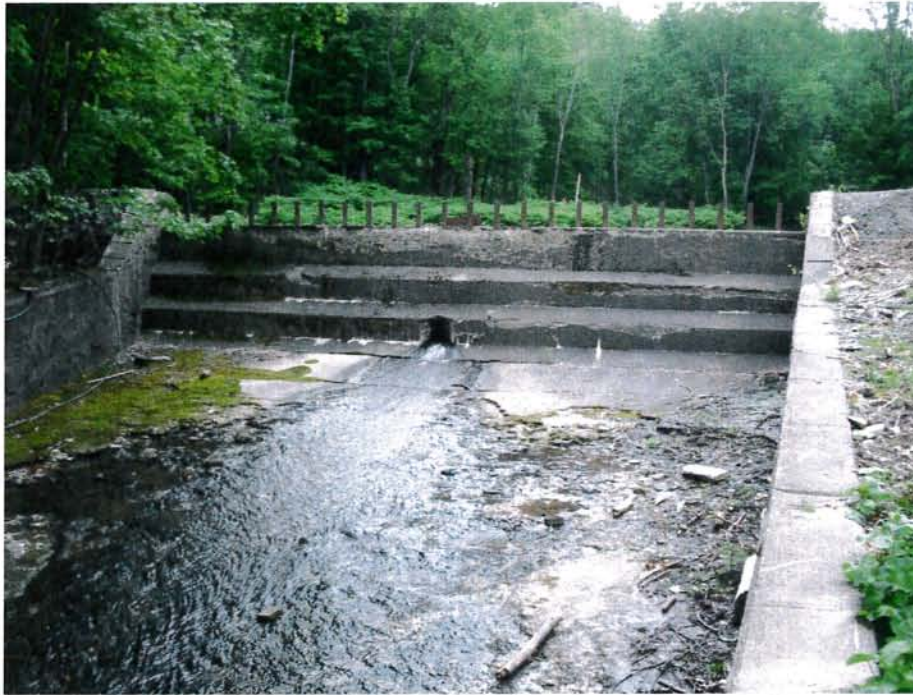
The approximate length of the spillway is 50 feet and its height approximately 6.5 feet as measured from the crest of the spillway to its downstream toe. On either side of the spillway are short sections of earthen embankment extending from the spillway training walls to original ground. The spillway itself is stepped on its downstream side (See photograph No. 1).

The dam's spillway is a reinforced concrete structure, approximately 6.5 feet tall and 50 feet in length as shown in Photograph No. 1. At the time of inspection, the spillway's concrete was observed to be in relatively poor condition, as seen in Photograph Nos. 7 & 8. Significant deterioration and erosion of its concrete surfaces were apparent, and, at or near the centerline of the spillway, this erosion has removed approximately 3 inches of concrete. At several locations, in particular along the upstream edge of the spillway crest, the concrete's reinforcing steel is exposed as seen in Photograph No. 12. Structural cracking was observed along the upstream face of the spillway as shown in Photograph No. 13. At the time of inspection, the crack extended from at or near the left abutment to a point near the drop-inlet structure. The width of the crack was estimated to range from hairline to nearly one (1) inch. Its depth could not be determined due to the presence of impounded water behind the dam, although it appeared to be limited. Areas of crazing were observed along the downstream face of the spillway and, at several of these locations, efflorescence was noted (Photograph Nos. 1, 7, & 8). On the downstream side of the spillway, efflorescence was observed at the base of each of the spillway's steps, as seen in Photograph Nos. 8 and 11.

- 1) Embankment Material The dam consists of a concrete spillway with earthen closure embankments on either side of the same. See Photograph No. 1. It is unknown what the material utilized to construct the earthen embankments consists of. Significant amounts of gravel and cobbles were observed to be present at grade along each of the closure embankments.
- 2) Cutoff Type Unknown.
- 3) Impervious Core Unknown.
- 4) Internal Drainage System Unknown. A series of pipes, spaced approximately 10 feet on-center and having an apparent diameter of 2 or 4 inches, were observed protruding through the left abutment wall (Photograph No. 2). No flow was observed emanating from these pipes at the time of inspection.

Photograph No. 1: Silver Creek Detention Basin Dam.

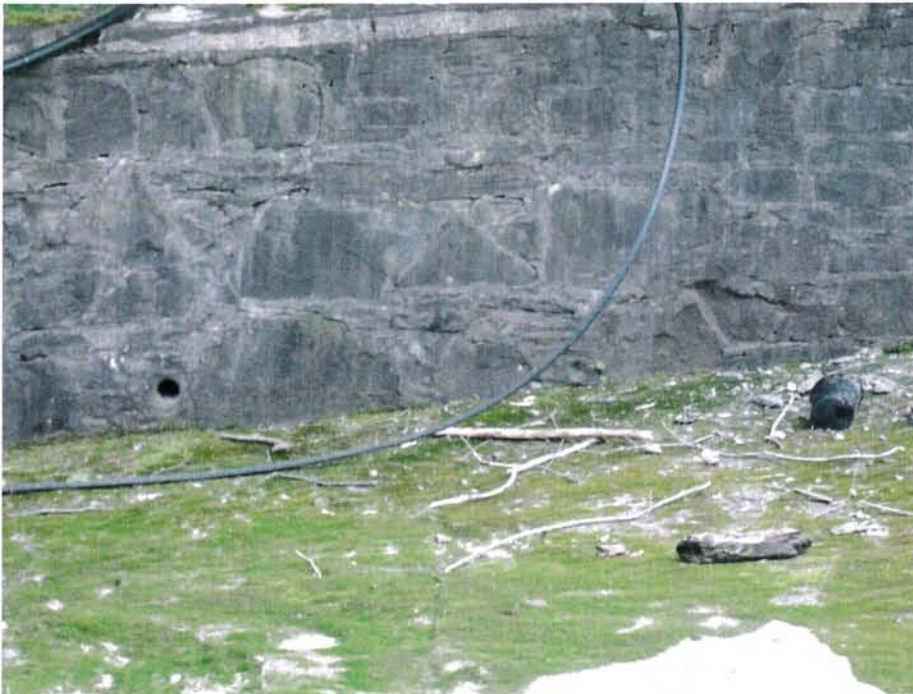
Photograph No. 2: Drain pipe along left abutment wall.

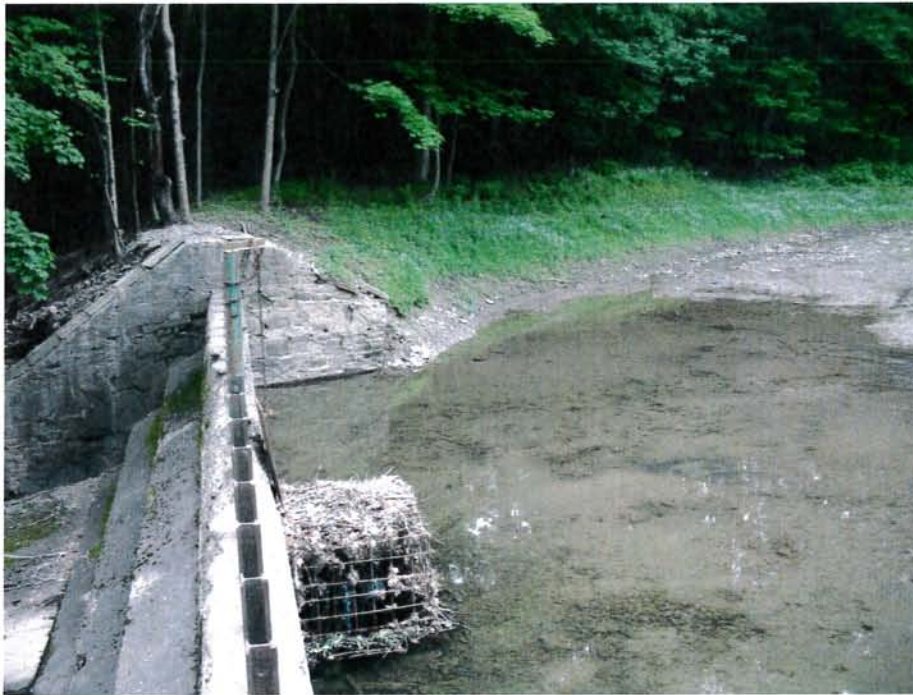
- 3) Sloughing, Subsidence or Depressions None observed.
- 4) Slope Protection None observed. See Photograph No. 3.
- 5) Surface Cracks or Movement of Toe None observed.

Photograph No. 3: Upstream slope of right closure embankment.

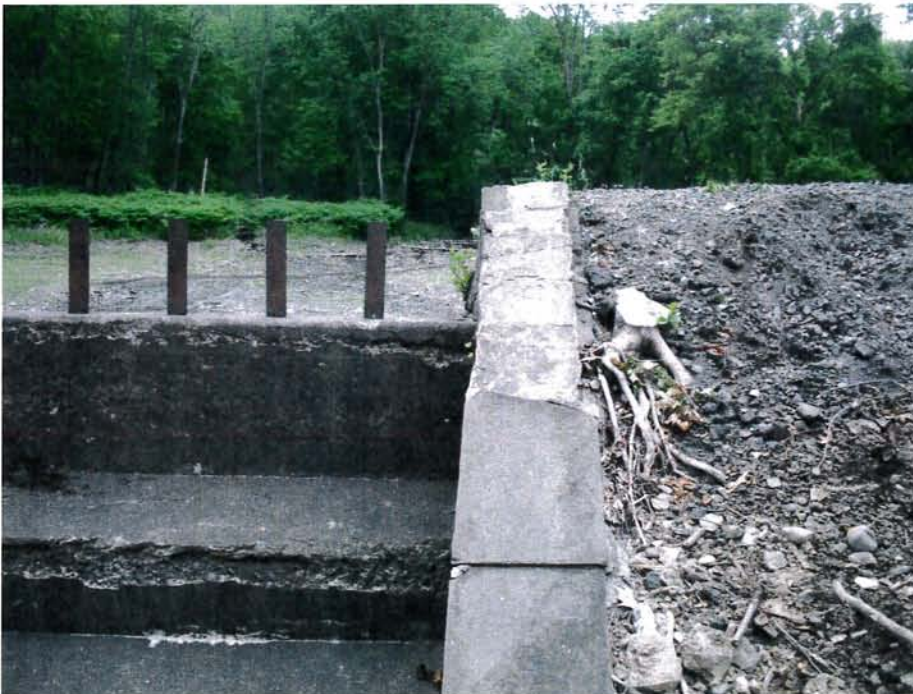
- 1) Slope (Estimate H:V) 2.5:1 by eye.
- 2) Undesirable Growth, Debris, or Animal Burrows Several trees, ranging in size from 2 to 6 inches in diameter, are present along the downstream slope of the right closure embankment. A stump and its associated root system are present on the left closure embankment as shown in Photograph No. 4. Sparse vegetative cover is present over most of the closure embankments downstream slopes. No animal burrows were observed.

Photograph No. 4: Tree stump and associated root mass on downstream slope of left closure embankment.

The crest and slopes of the closure embankments should be maintained in a groomed condition to facilitate their visual inspection for signs of seepage, erosion, animal burrows, and slope instability. At the time of inspection, numerous trees ranging in diameter from 1 to 4 inches were present on the right closure embankment and little to no vegetative cover was present across large portions of both embankments. The remains of a tree stump and its associated root mass were present immediately behind the left abutment.

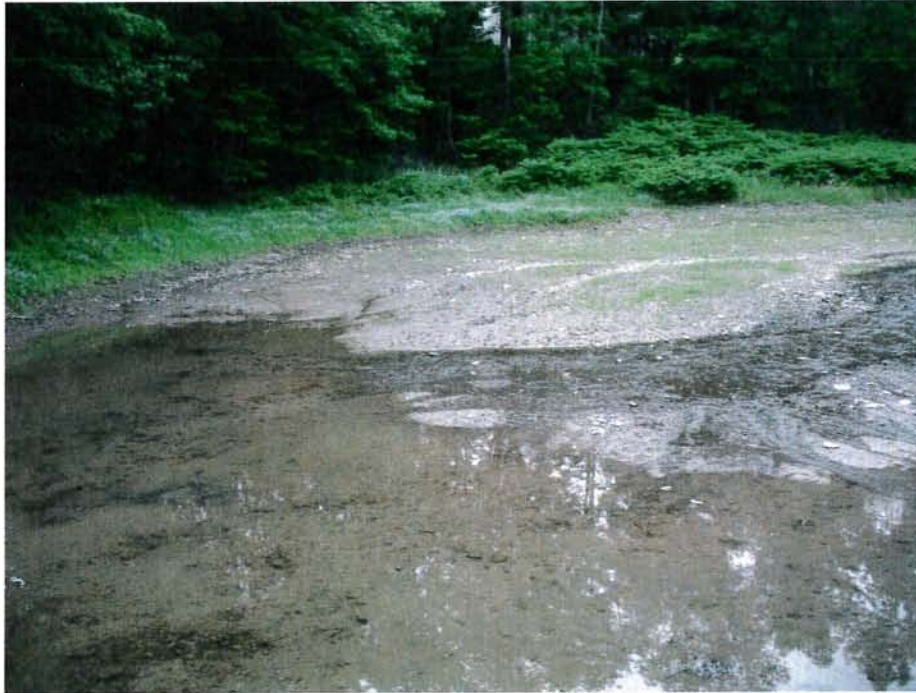
- 4) Surface Cracks or Movement at Toe None observed.
- 5) Seepage No seepage was observed. At the time of inspection, less than 1 foot of water was present within the detention basin. See Photograph No. 5.

Photograph No. 5: Area upstream of Silver Creek Detention Basin Dam.

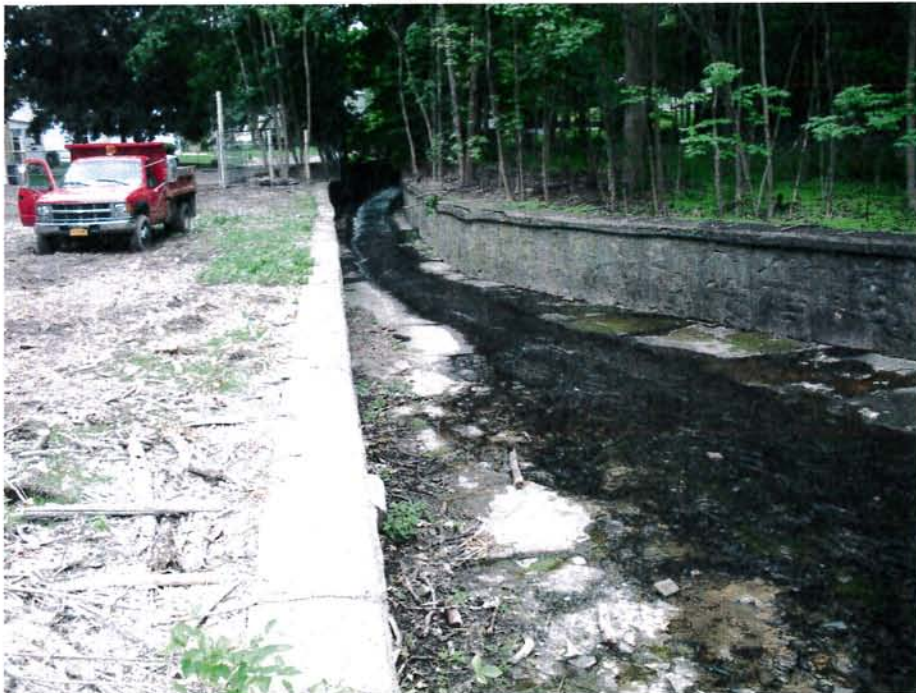
At the time of the Initial Safety Inspection, little flow was entering the downstream channel allowing for its inspection (Photograph No. 6). For a distance of several hundred feet downstream of the dam, the downstream channel consists of a cyclopean concrete base slab with grouted masonry training walls. The channel's concrete base slab was in poor to fair condition, with moderate to severe deterioration observed. In some areas, the base slab has experienced up to 3 inches of erosion and has exposed the cyclopean concrete's aggregate (Photograph No. 9). Sedimentation and vegetative growth was observed in isolated areas.

- b. Seepage, Growth Significant vegetative growth, such as trees, brush, and grass, is present along either side of the downstream channel for a distance of several hundred feet downstream of the dam as shown in Photograph No. 6. No seepage was observed within the downstream channel extending to a distance of approximately 50 to 100 feet downstream of the dam.
- c. Evidence of Movement Beyond Toe of Dam None observed.
- d. Condition of Downstream Channel For several hundred feet immediately downstream of the dam, the downstream channel consists of a concrete base slab with grouted masonry training walls. The depth of channel within the first 100 to 200 feet is between 4 to 6 feet. At the time of inspection, the channel was observed to be relatively free of debris and the concrete and masonry appeared to be in fair condition. See Photograph No. 6.

Photograph No. 6: Downstream channel.

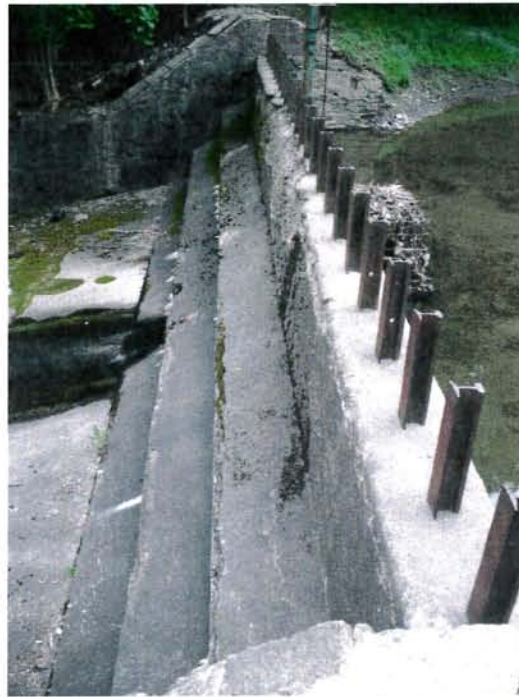
- a. Concrete Surfaces Significant weathering and deterioration were observed of all the dam's concrete surfaces, as shown in Photograph Nos. 7, 8 & 11. As much as 3 to 5 inches of concrete has eroded in some areas, with those areas closest to the dam's centerline having experienced the greatest amount of deterioration. Some areas of crazing were also observed.

- c. Movement - Horizontal & Vertical Alignment (Settlement) No apparent settlement has occurred. Severe erosion and deterioration of the dam's concrete has occurred, resulting in variations from vertical alignment along the length of the crest as shown in Photograph Nos. 7 & 8.

Photograph No. 7: Concrete spillway of Silver Creek Detention Basin Dam.

Moderate deterioration was observed of the dam's concrete gravity section/spillway, including but not limited to erosion/spalling, pitting, crazing and structural cracking. It is recommended that structural cracks be sealed through injection of a polyurethane resin and the crack surface sealed with the application of a cementitious waterproofing mortar.

Once this work has been completed, it is recommended that the dam's gravity section and the concrete base slab of the discharge channel be resurfaced through the application of shotcrete. Any "unsound" or deteriorated concrete should be removed prior to the restoration of the concrete surface.

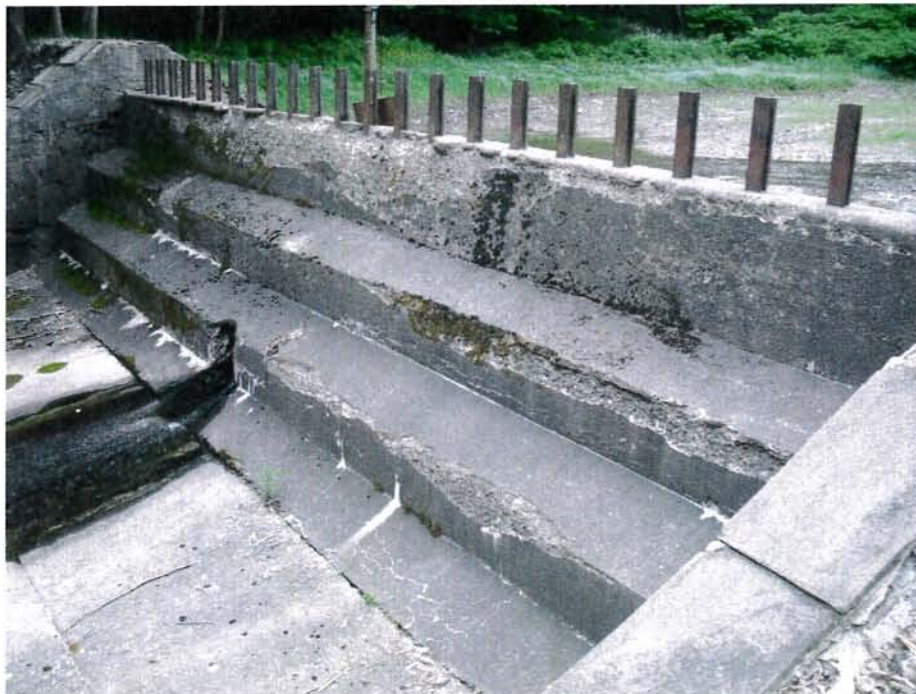
- b. Condition of Service Spillway The concrete comprising the dam's spillway is generally in poor condition, as shown in Photograph No. 8. Severe weathering and erosion has occurred of all concrete surfaces and reinforcing steel is exposed at several locations.

Photograph No. 8: Weathering and erosion of Silver Creek Detention Basin Dam.

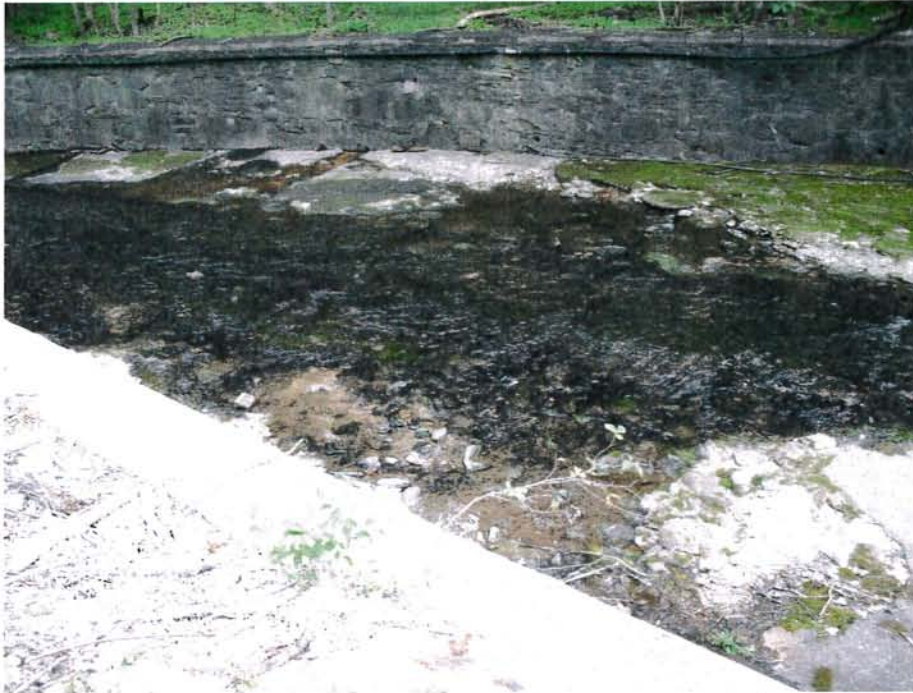
- d. Condition of Discharge Channel Fair. The base slab, which appears to consist of cyclopean concrete, has been heavily eroded and significant erosion was observed as shown in Photograph No. 9. This erosion appears to be as great as 3 inches in those areas in close proximity to the dam. The discharge channel's walls appear to be constructed of grouted stone masonry. Moderate signs of weathering and erosion were noted of the mortared joints, and at several locations, no mortar was observed. Moss and other vegetation were observed growing across the surface of portions of the channel walls.

base slab's cyclopean concrete is exposed as shown in Photograph No. 9. Some minor debris was observed within the channel.

Photograph No. 9: Weathering and deterioration of downstream channel.

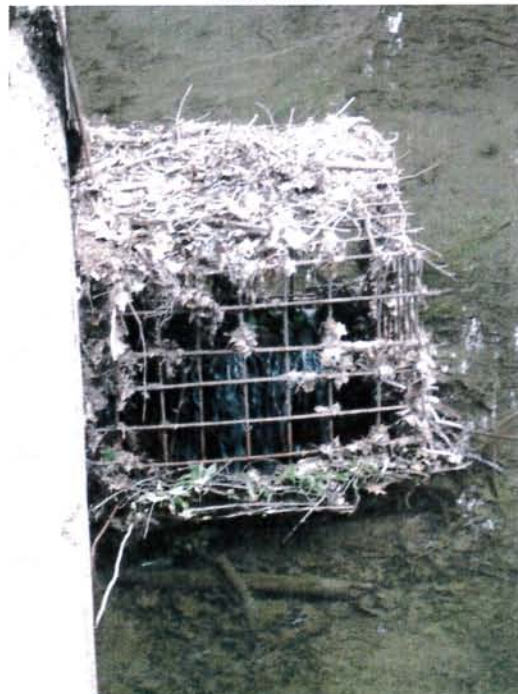
- j. Intake Structures Very little could be observed of the drop-inlet structure, and it appears to be in fair condition. A trash rack is present over the drop-inlet structure and at the time of inspection was observed to be covered with vegetation and other debris (Photograph No. 10).
- k. Stability No signs of structural instability were observed.
- l. Miscellaneous A series of steel posts are present along the crest of the spillway, extending above the crest by approximately 2 feet, as seen in Photograph Nos. 7 & 8. These posts were reportedly utilized for placement of flashboards across the crest of the dam's spillway.

Photograph No. 10: Drop-inlet structure.

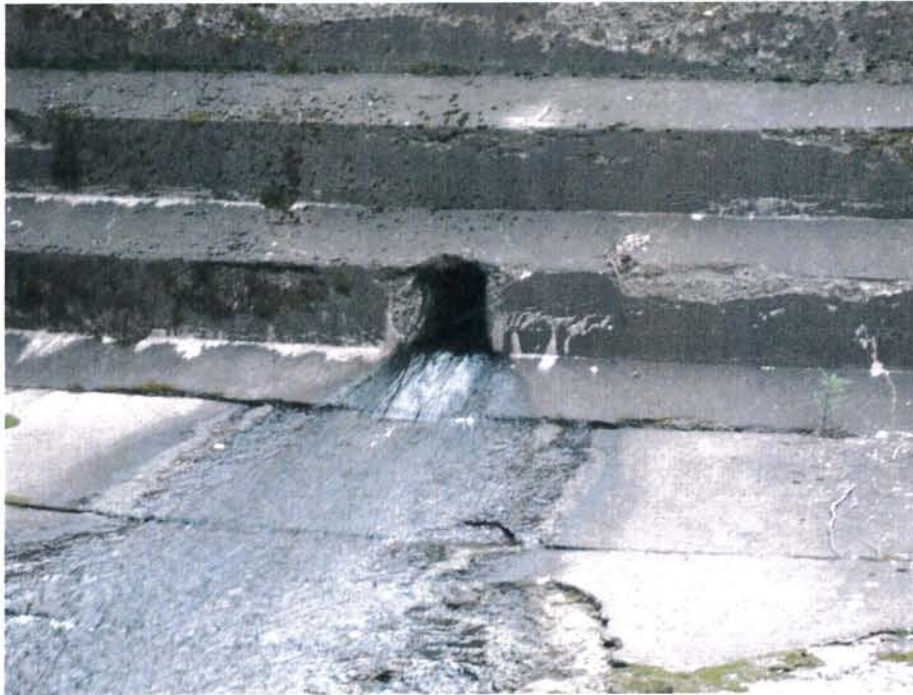
- e. Physical Condition (Describe) Very little could be observed of the drop-inlet structure due to accumulation of sediment and debris around the structure. Severe weathering/erosion of the concrete was observed in and around the rectangular outlet channel's downstream end (Photograph No. 11). The upstream end of the outlet could not be observed.

- e. Water Passages, Conduits, Sluices Significant deterioration has occurred along the downstream end of the rectangular outlet channel as shown in Photograph No. 11.

- f. Seepage or Leakage No seepage was observed at the time of inspection, although efflorescence was observed at the base of each of the terraces along the downstream level as seen in Photograph No. 11

Photograph No. 11: Outlet from drop-inlet structure.

Minor seepage was observed to be occurring through the dam's concrete gravity section as evidenced by efflorescence visible at the base of the downstream terraces. This seepage should be eliminated through the injection of an acrylic based grout into each of the joints.

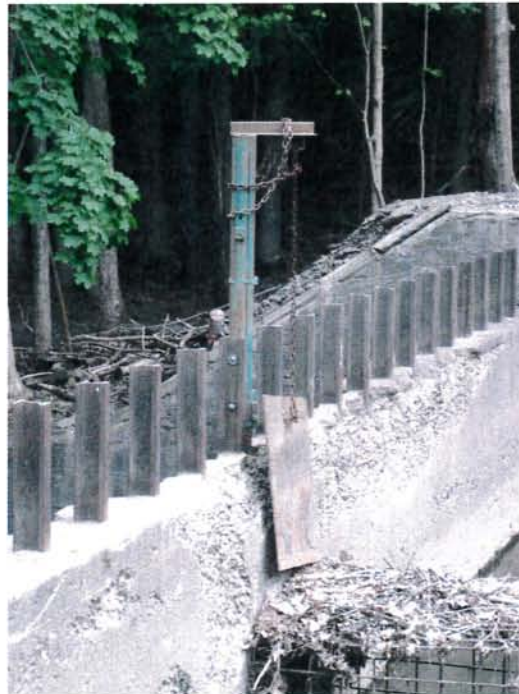
- Operation: The plate does not appear to have been used recently.
- Present Condition The plate is in fair condition, with moderate amounts of deterioration due to weathering observed.

Photograph No. 12: Steel plate used to close outlet of drop-inlet structure.

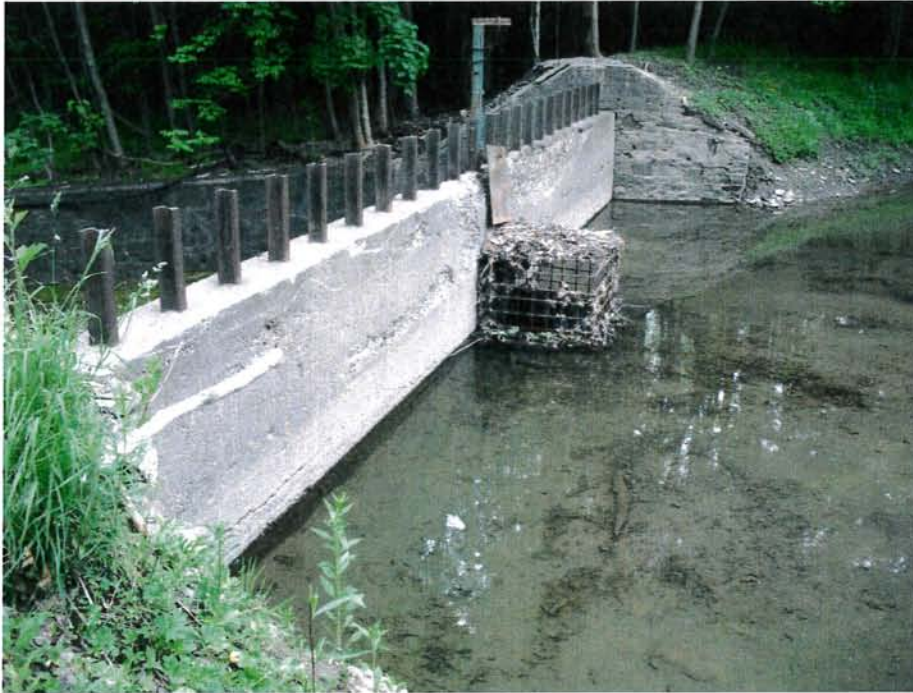
- b. Structural Cracking Several cracks were observed, with the most pronounced of these being along the upstream face of the spillway as shown in Photograph No. 13. A near continuous crack runs along the length of the spillway from at or near the left abutment to a point just to the left of the drop-inlet structure. The width of this crack ranged from hairline to as much as 1 inch. Areas of crazing were observed along the downstream face of the spillway, and efflorescence was observed emanating from many of these cracks and from the base of each of the terraces along the downstream face of the spillway.

Photograph No. 13: Upstream face of dam's spillway section.
Structural crack noted in foreground above water line.

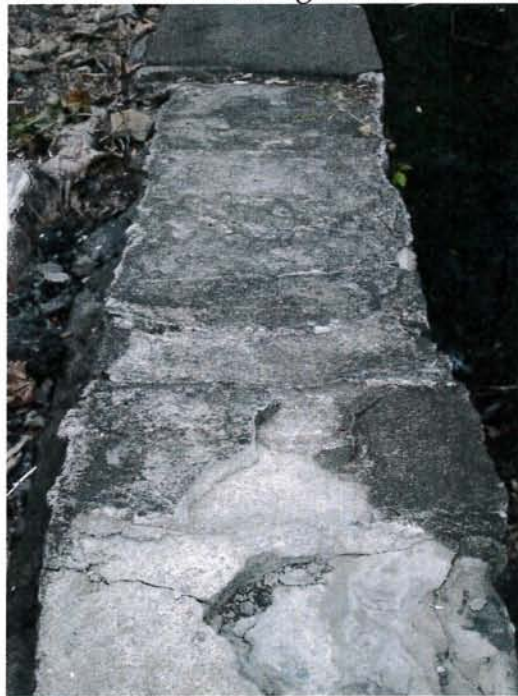
Grouted masonry training walls are present at the transition point between the concrete gravity section and a pair of small earthen closure embankments to each side of the spillway. A series of small diameter pipes (either 2 or 4 inch) were observed daylighting through the training walls and discharge channel walls at approximate 10-foot intervals (Photograph No. 2). The training walls appeared to be in fair condition, with only modest amounts of deterioration noted of the mortar. Concrete placed as caps over the walls have experienced moderate deterioration of their surfaces as shown in Photograph No. 14.

- d. Junctions with Abutments or Embankments Good, no significant gaps or openings were observed along either side of the spillway. Soil was observed to be tight against the training walls (See Photograph No. 14).

Photograph No. 14: Training wall-embankment interface.
