Re: Environmental Investigation at the Blodgett Drive Site in the
City of Oneonta, Otsego County, New York
TES File No. 3807

As requested, Terrestrial Environmental Specialists, Inc. (TES) performed an environmental investigation at a site in the City of Oneonta, Otsego County, New York. The site is approximately 14 acres in size and is located north of Blodgett Drive. A student housing project is proposed at the site.

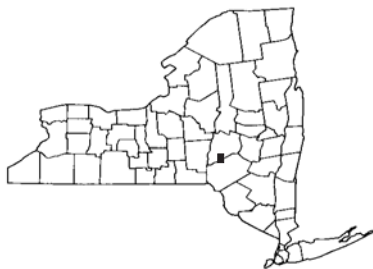
Figure 4. Soil Survey Map

The NRCS Soil Survey map shows a variety soil types on the site (Figure 4). These soil types include Lordstown, Chadakoin, and Manlius soils, 25 to 50 percent slopes, very rocky (LrE); Mardin channery silt loam, 8 to 15 percent slopes (MeC); Oquaga-Arnot complex, 1 to 8 percent slopes, rocky (OgB); and Oquaga-Arnot complex, 8 to 15 percent slopes, rocky (OgC) (Figure 4). None of these soil types are listed by the NRCS (formerly the USSCS) as hydric (wetland) soils (USDA NRCS 2012).

- LrE - Lordstown, Chadakoin, and Manlius soils, 25 to 50 percent slopes, very rocky
- MeC - Mardin channery silt loam, 8 to 15 percent slopes
- OgB - Oquaga-Arnot complex, 1 to 8 percent slopes, rocky
- OgC - Oquaga-Arnot complex, 8 to 15 percent slopes, rocky

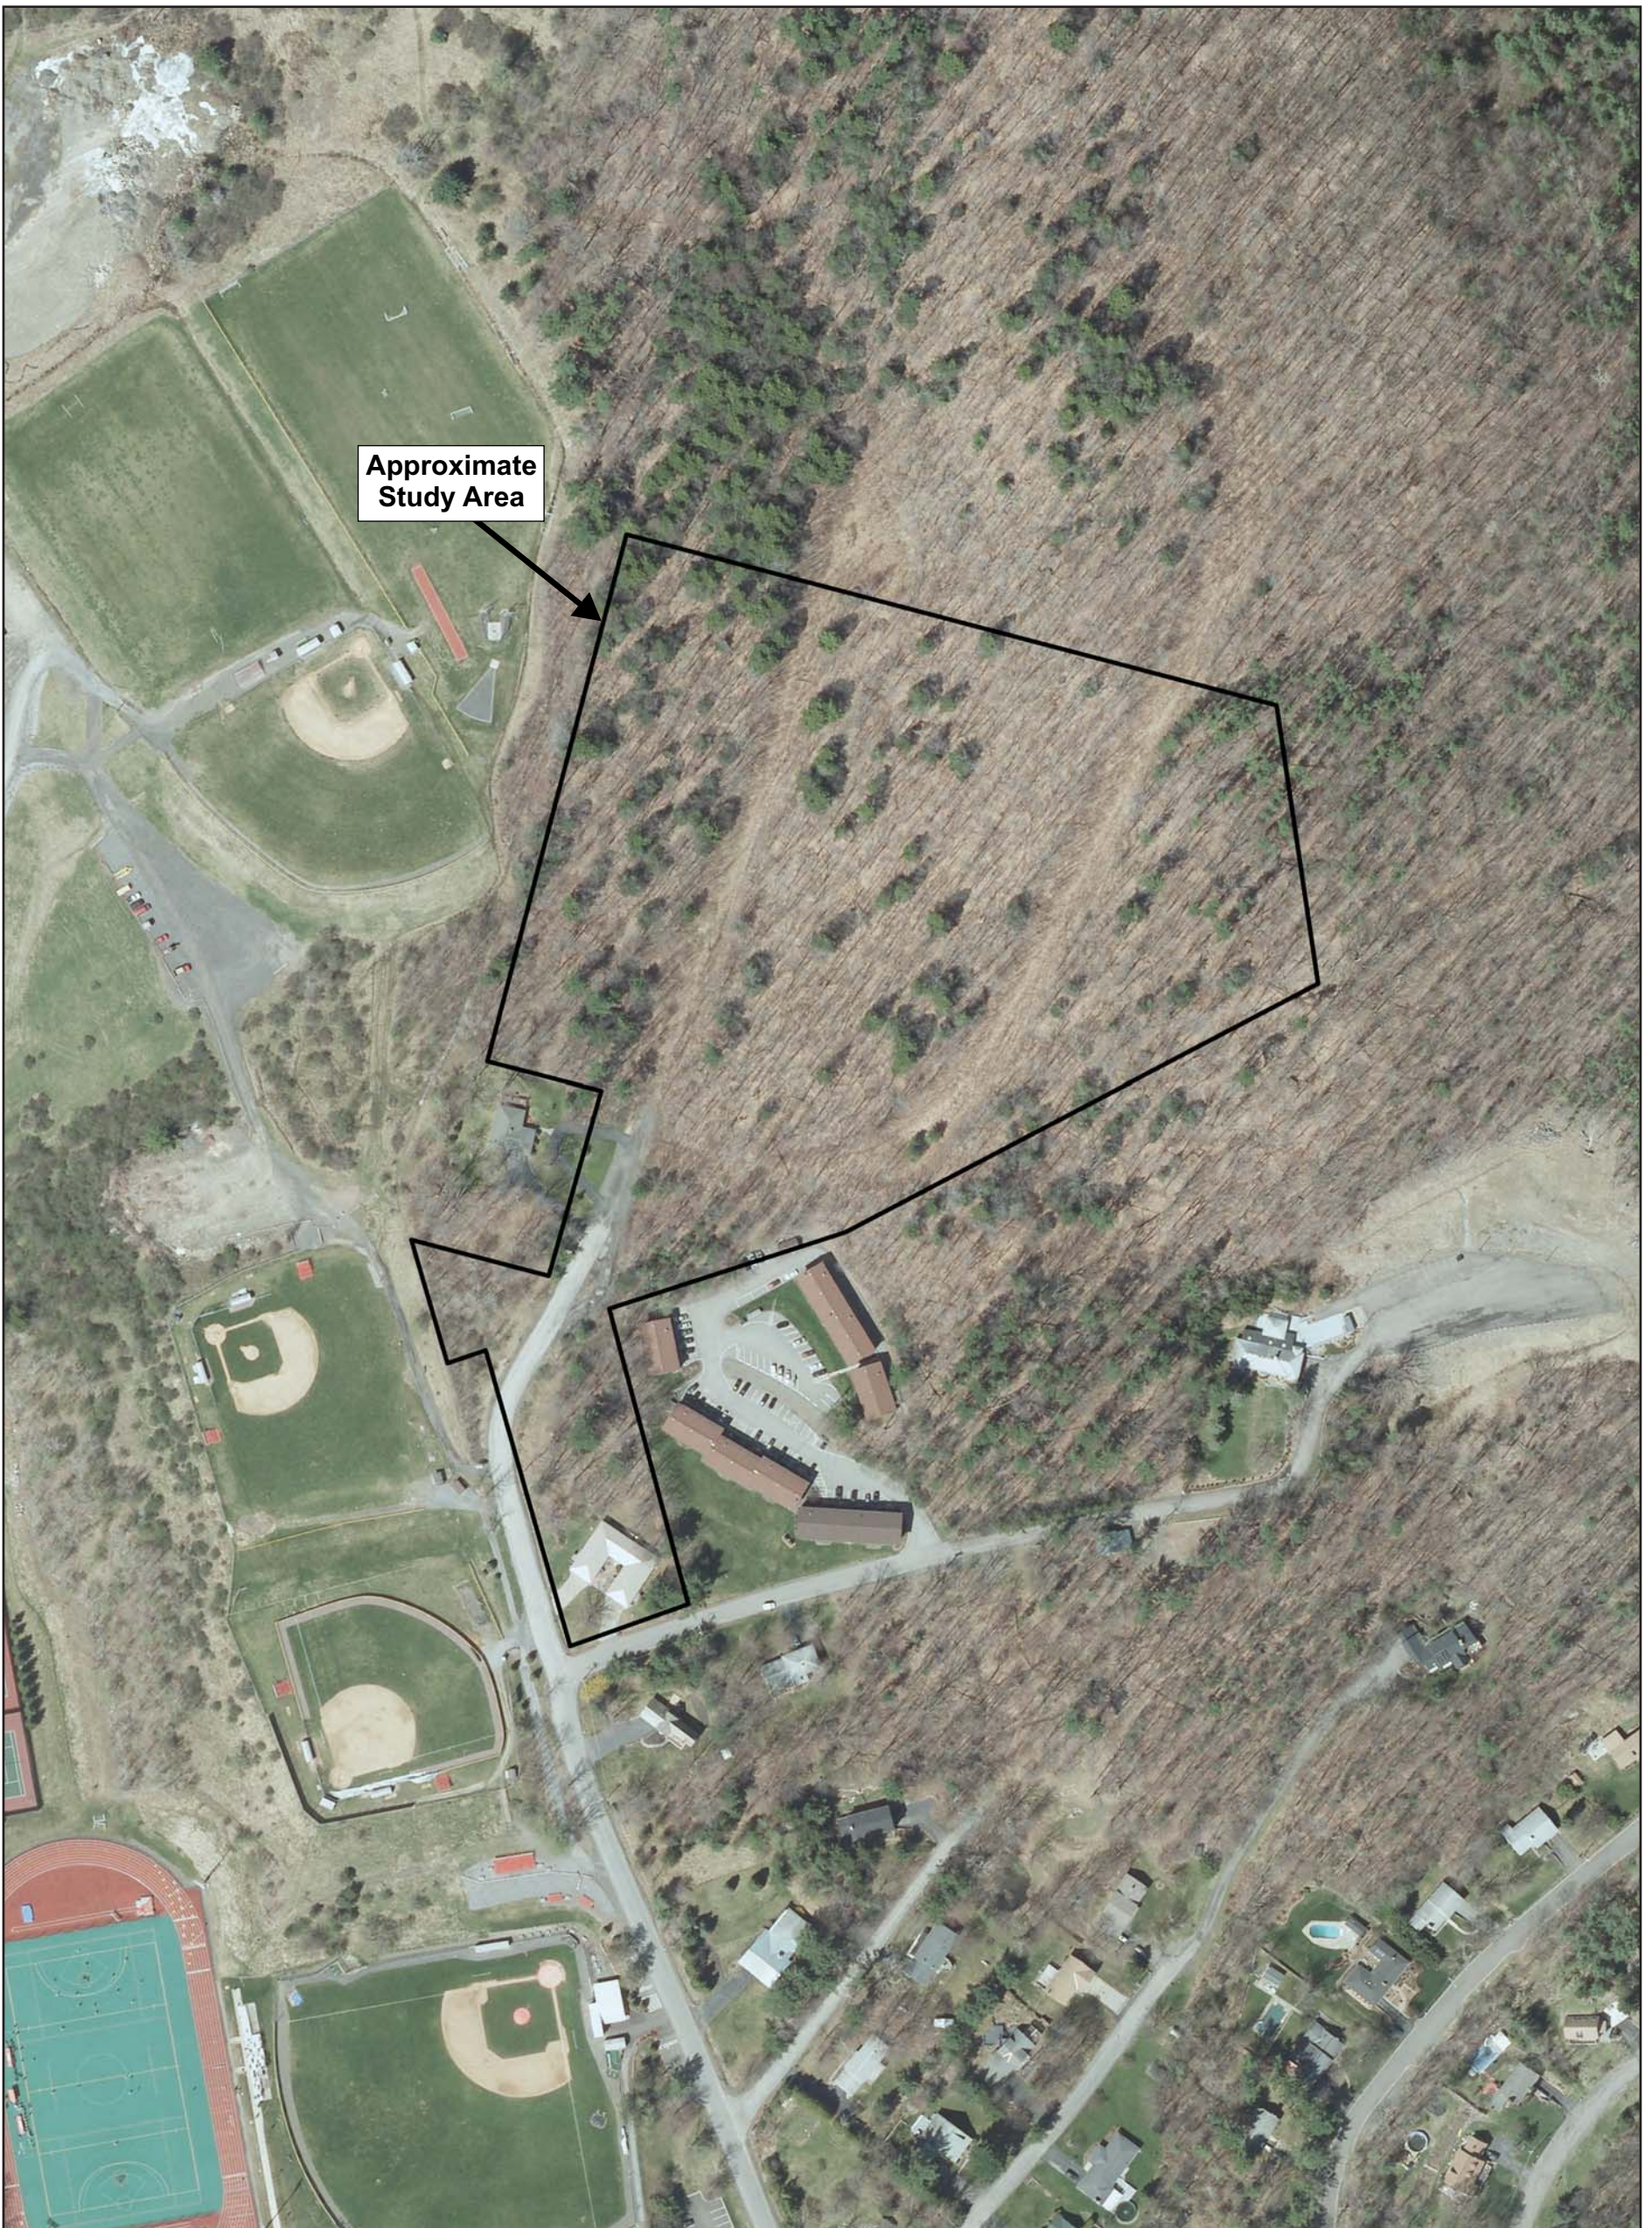
Figure 6.
Aerial Photograph of Site

The 2010 aerial photograph shows that the site is primarily wooded land (Figure 6). Residential and undeveloped lands border the site.

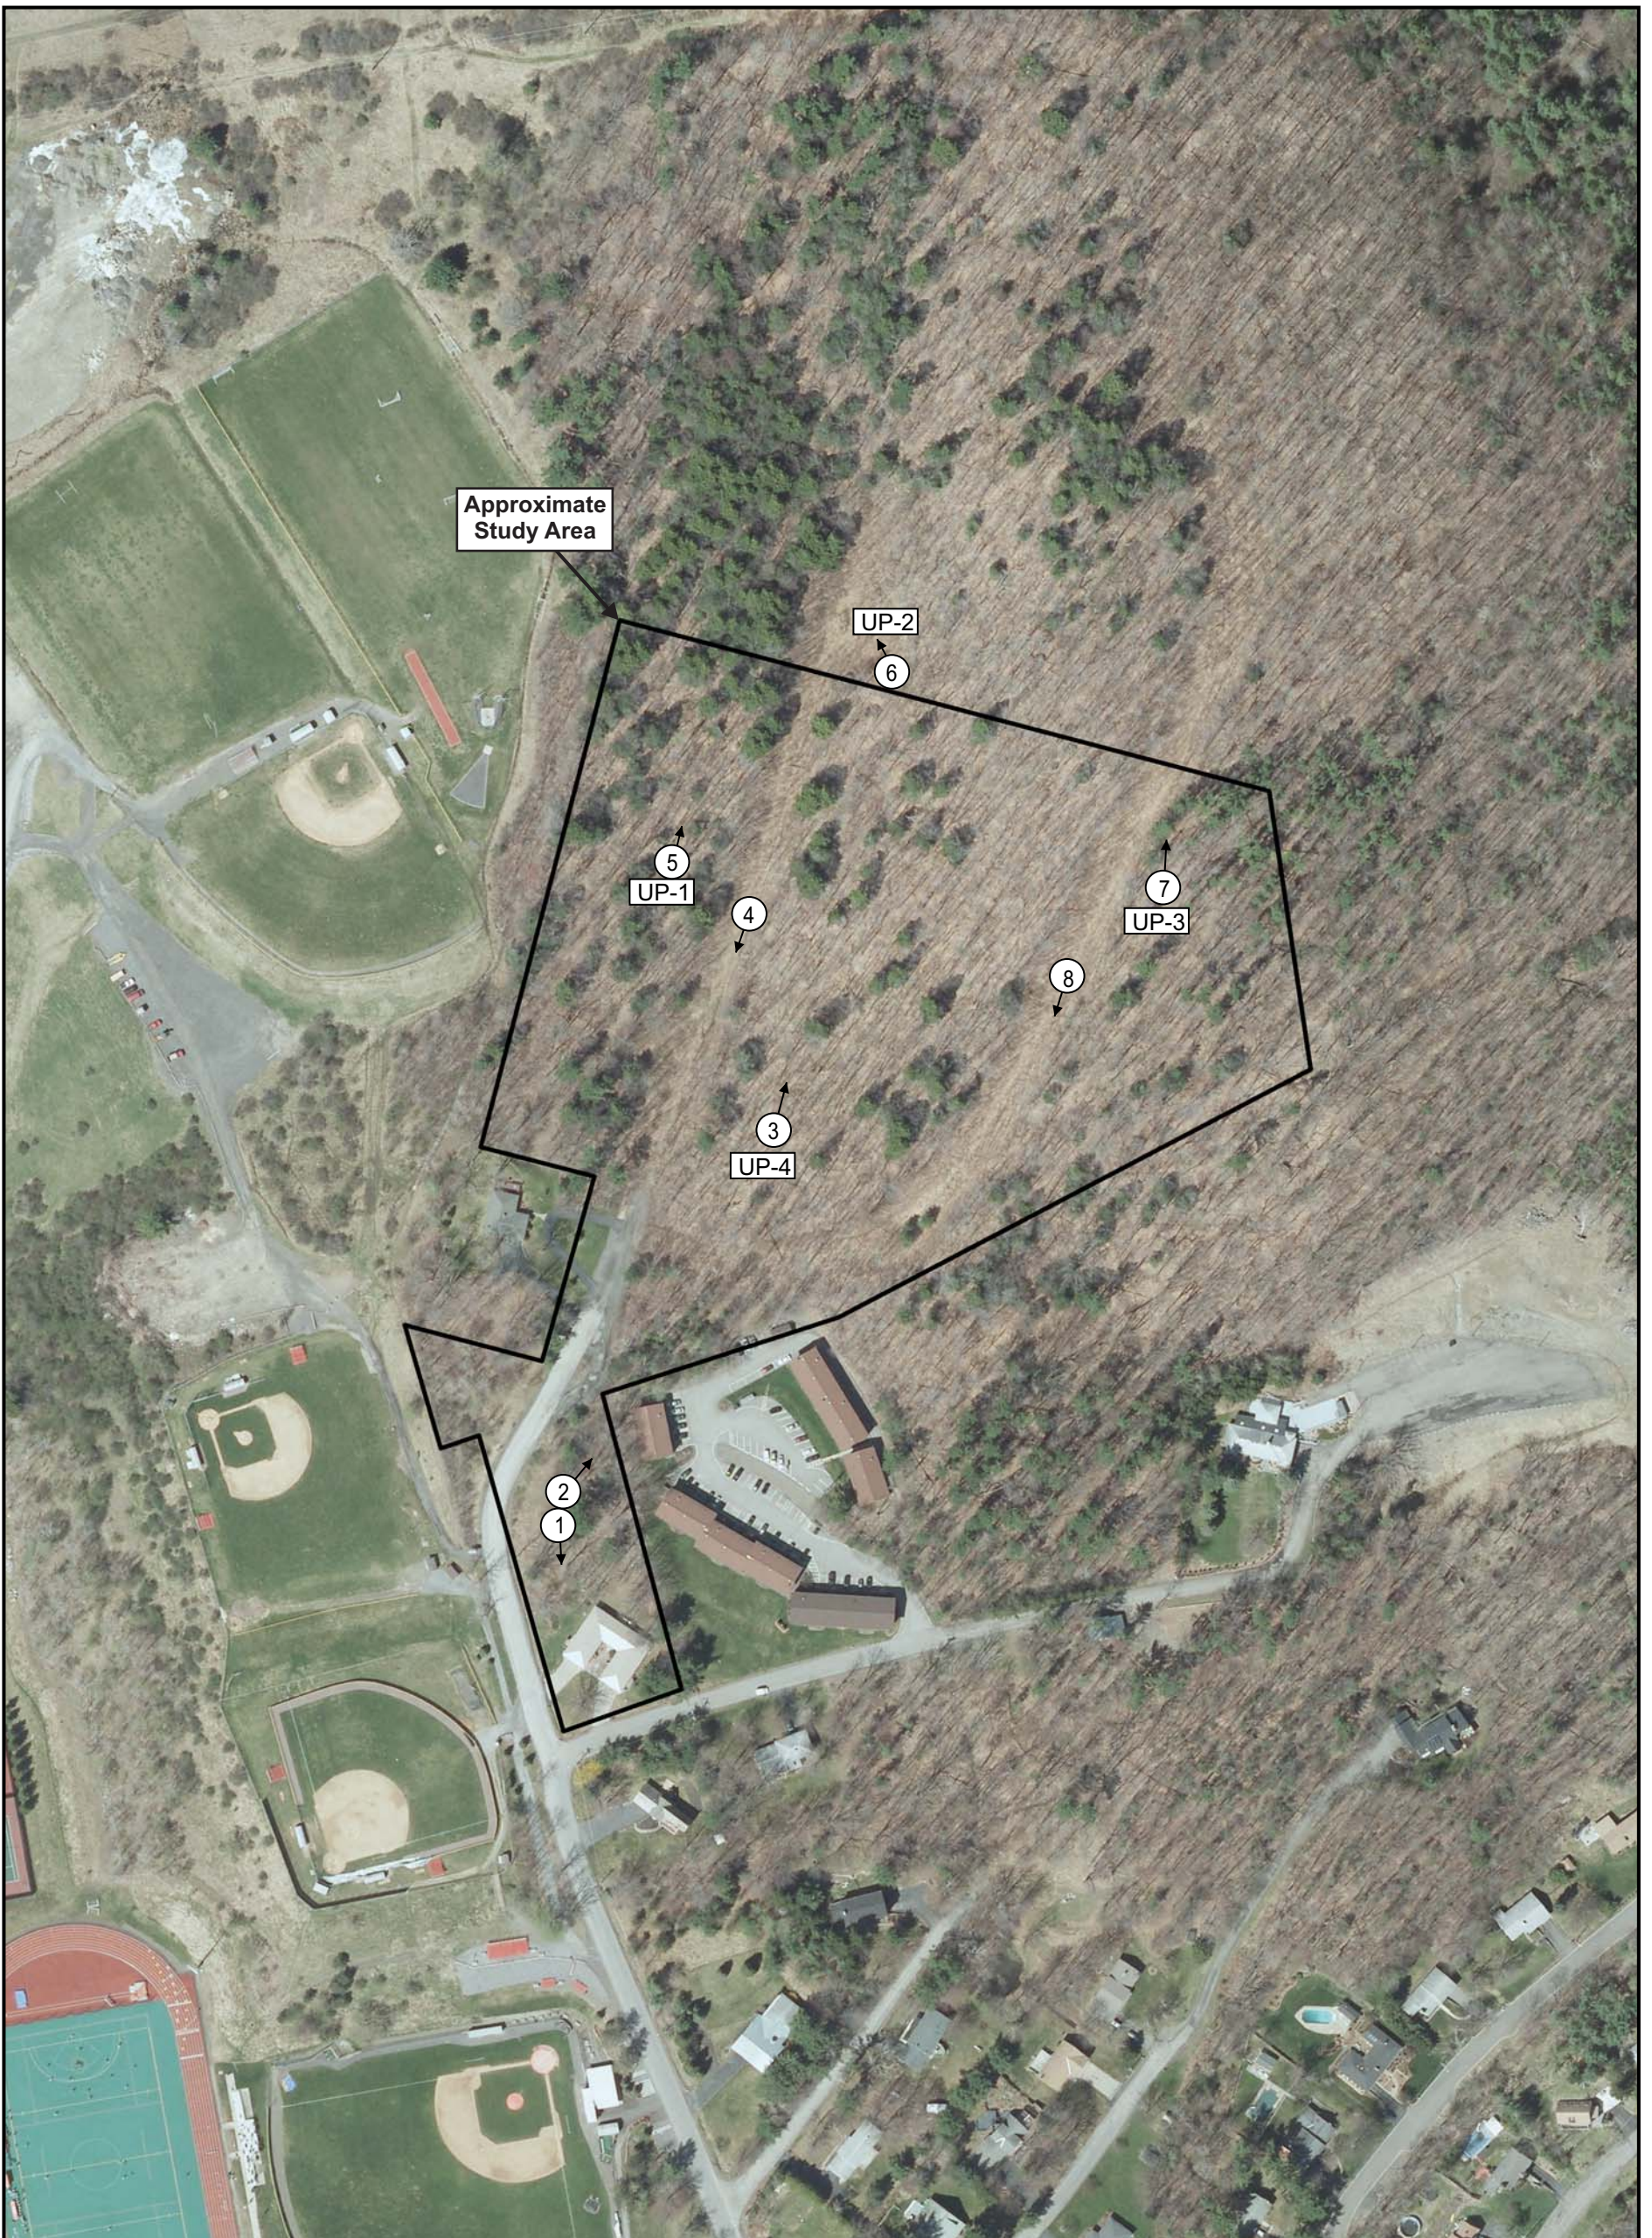
Figure 8.

Based on our field review, there are no areas of the site that meet the three parameter criteria for identifying wetlands according to the methods described in the Corps 2012 Supplement to the 1987 Wetlands Delineation Manual. The site consists primarily of deciduous forest upland cover type (Figure 7). TES took photographs (Attachment C) and collected sample plot data and recorded vegetation, soils, and hydrologic conditions (Attachment D). Photograph and sample plot locations are shown on Figure 7.

**Wetland Boundaries
with Sample Plot and
Photograph Locations**

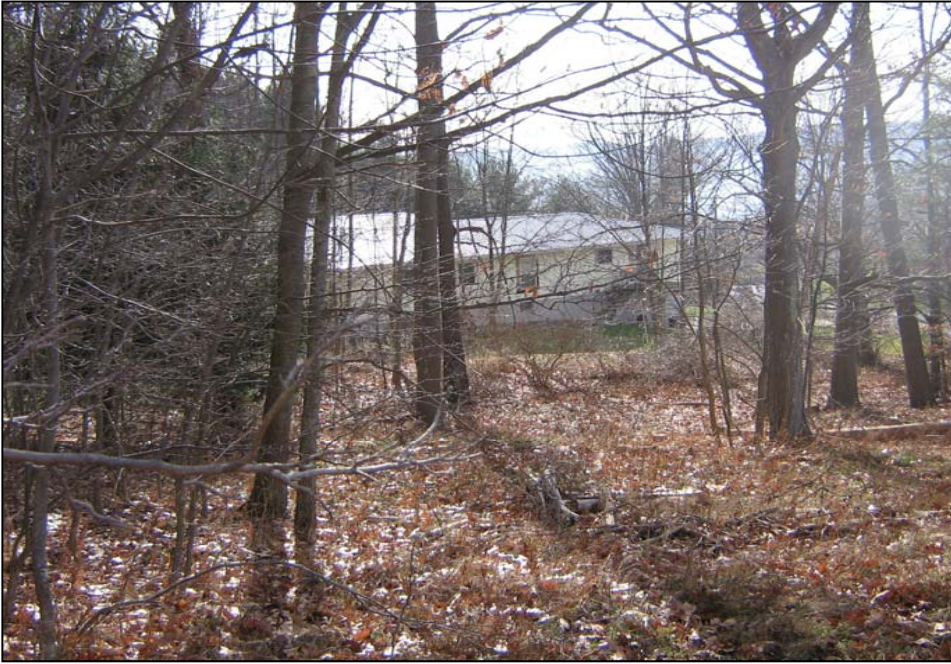
Photo 1. Photo Facing South in Southern Portion of Study Area

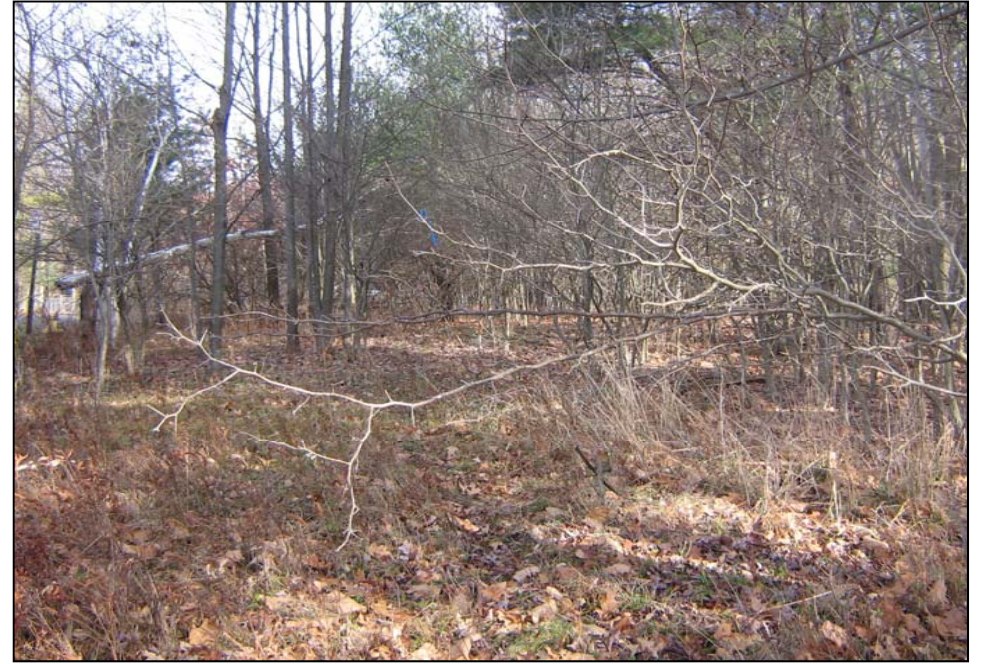
Photo 2. Photo Facing North in Southern Portion of Study Area

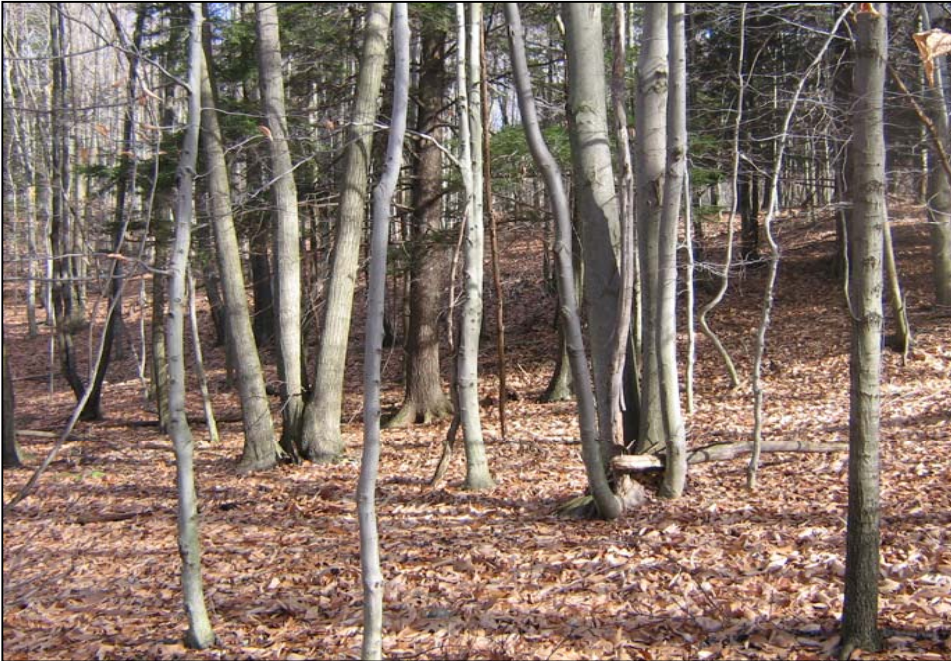
Photo 3. Plot UP-4 Facing North

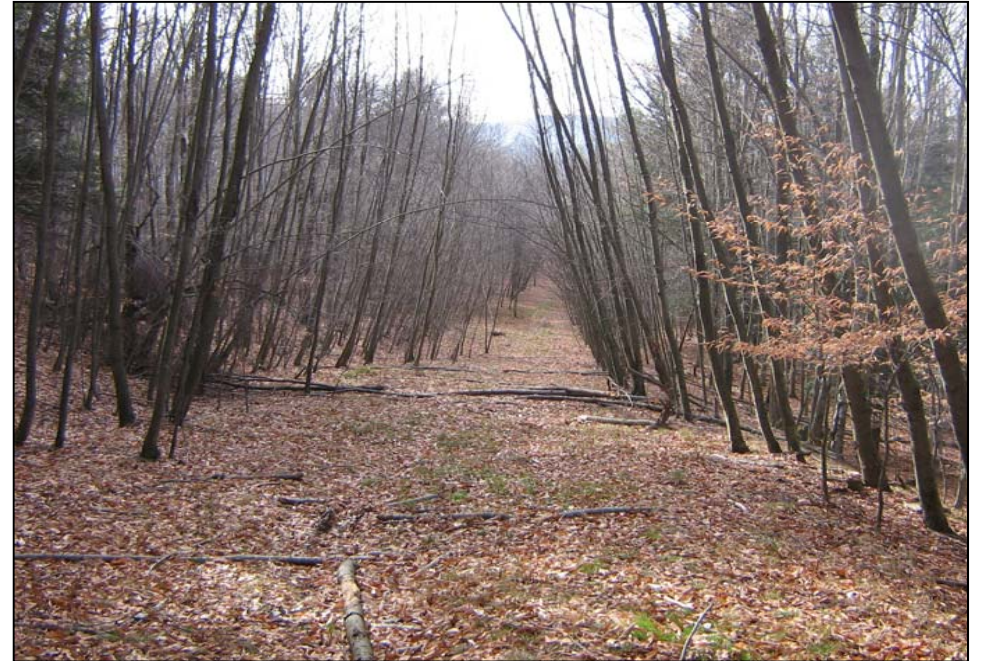
Photo 4. Photo Facing North Along Trail Path

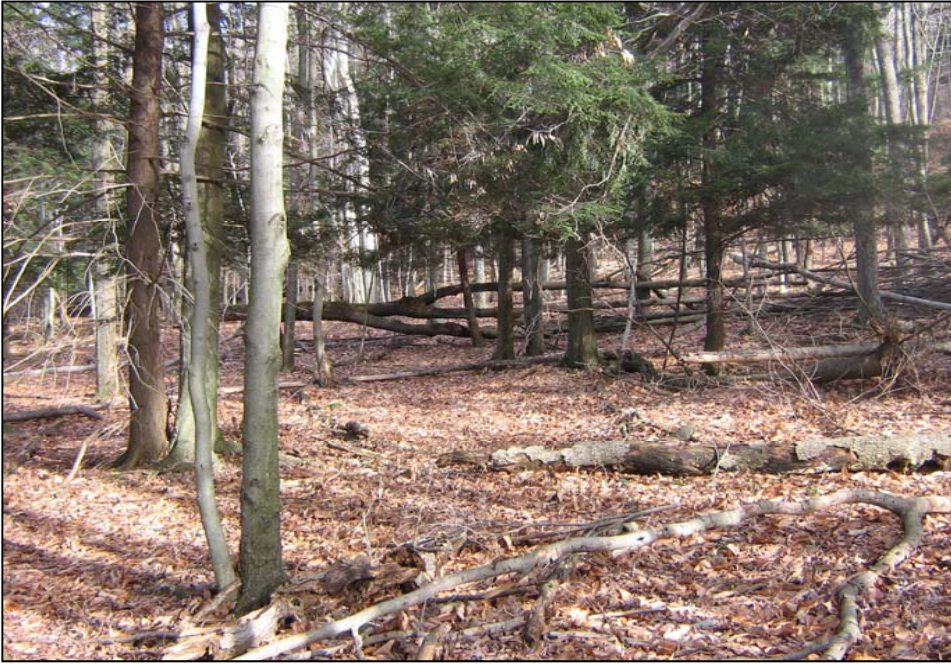
Photo 5. Plot UP-1 Facing North

Depth (inches)	Matrix			Redox Features					Texture	Remarks
	Color (moist)	%		Color (moist)	%	Type ¹	Loc ²			
0-3	10YR	3/2	100%						Silt Loam	
3-6		5/6	60%	10YR	4/4	40%	D	M	Silt Loam	Rock below

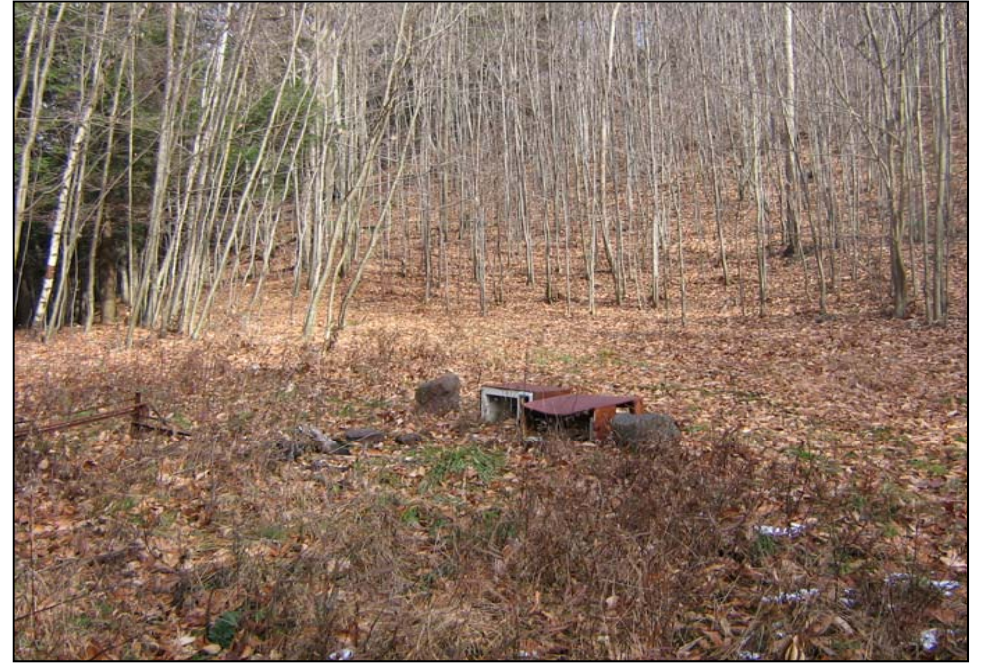
Photo 6. Plot UP-2 Facing Northwest

Depth (inches)	Matrix		Redox Features				Texture	Remarks
	Color (moist)	%	Color (moist)	%	Type ¹	Loc ²		
0-6	5Y	4/3	100%				Silt Loam	Rock bel ow

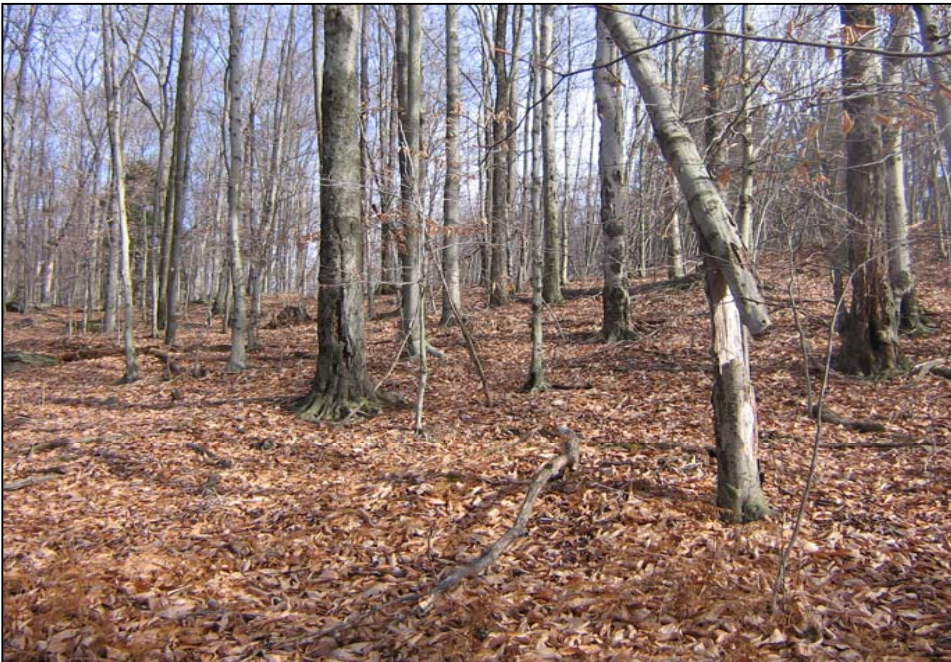
Photo 7. Plot UP-3 Facing North

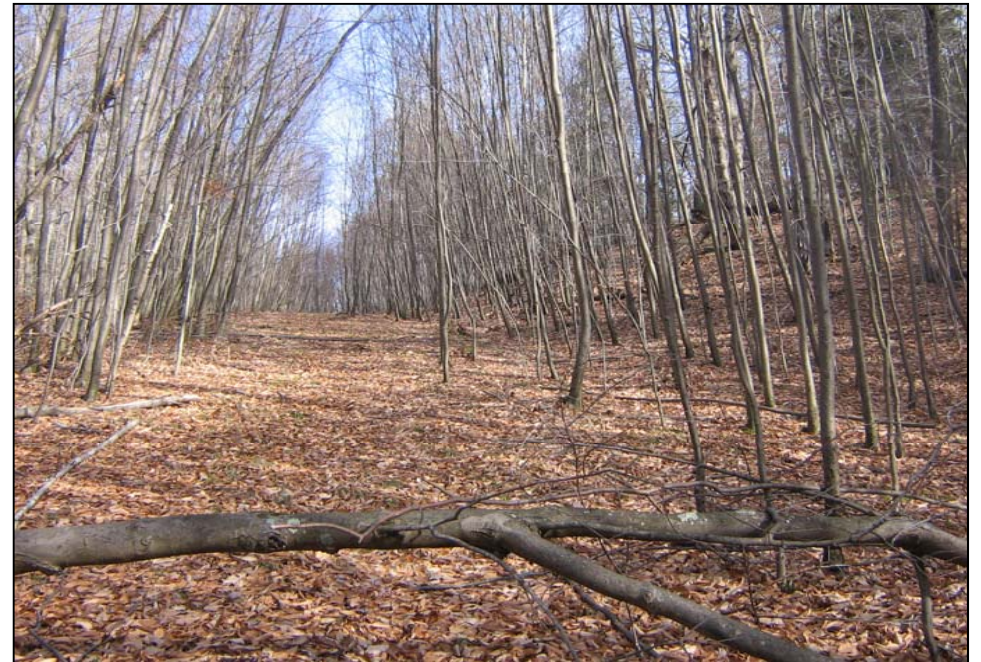
Photo 8. Photo Facing South Along Trail Path

Hydrophytic Vegetation Present? Yes <input type="radio"/> No <input checked="" type="radio"/> Hydric Soil Present? Yes <input type="radio"/> No <input checked="" type="radio"/> Wetland Hydrology Present? Yes <input type="radio"/> No <input checked="" type="radio"/>	Is the Sampled Area within a Wetland? Yes <input type="radio"/> No <input checked="" type="radio"/> If yes, optional Wetland Site ID: <input style="width: 100px;" type="text"/>
Remarks: Photo # 8
